EGG-TMI-7429

TMI-2 LOWER PLENUM VIDEO DATA SUMMARY

Published July 1987

EG&G Idaho, Inc.  
Idaho Falls, Idaho 83415

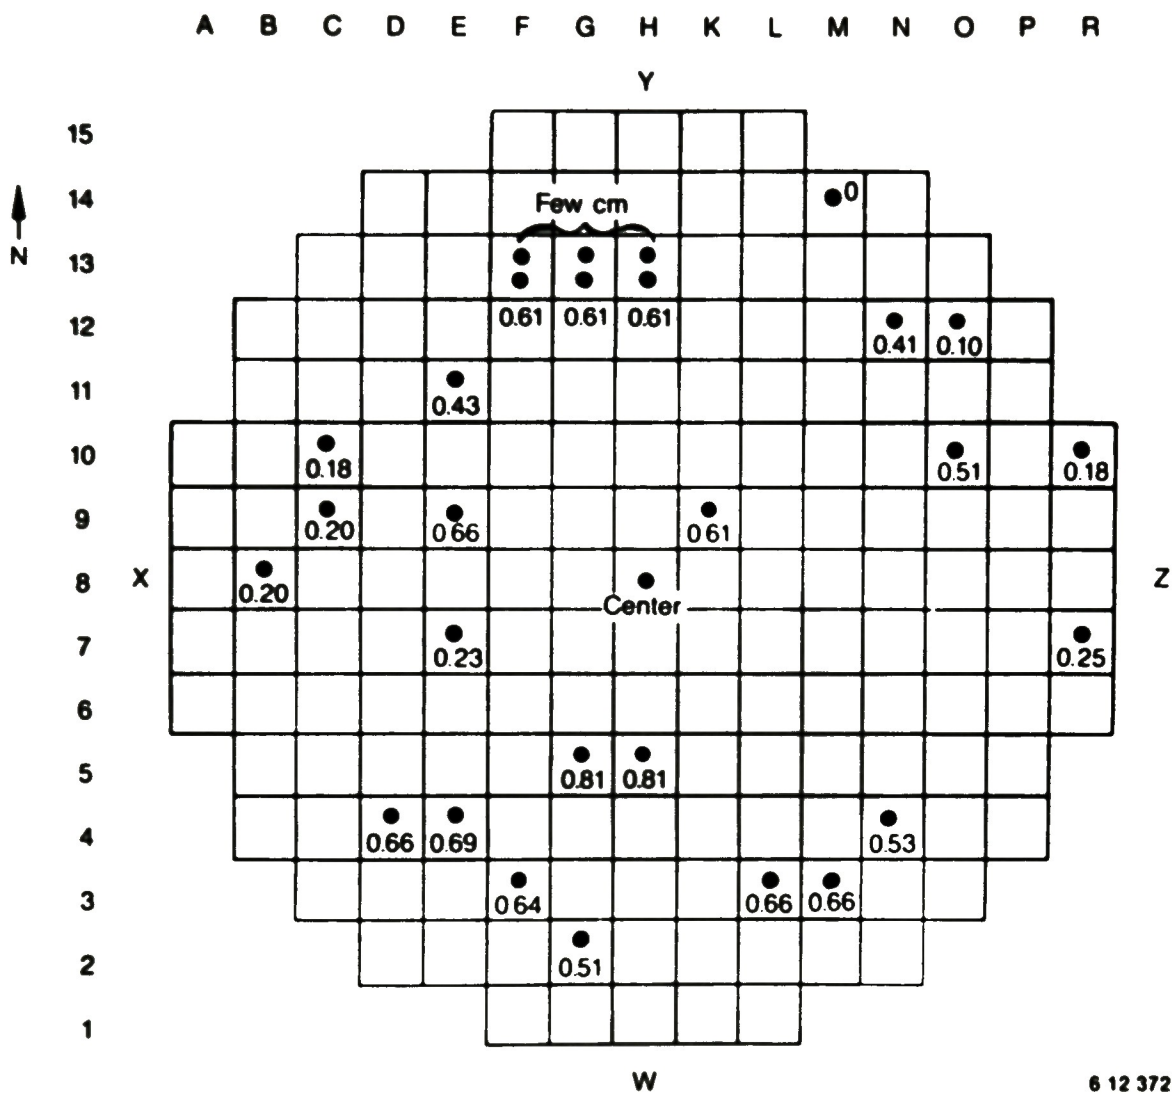
Figure 3 shows the measured and estimated lower plenum debris bed depths as derived from the video data. The core grid is superimposed for reference. The debris bed depth data shown in Figure 3 were estimated using two techniques. For those locations examined using a camera inserted into the downcomer annulus, the debris bed height was estimated by comparing the top surface of the bed to the instrument guide tubes at various locations. The depth could then be estimated using the known geometry of these guide tubes. The detailed geometries of all guide tubes used in this study are shown in Appendix A. For the three lower plenum locations examined during the core-boring operations, grid locations K-9, D-4, and N-12, the camera was lowered to the top of the debris bed and then

Figure 3. TMI-2 lower plenum debris bed depth measurements.

withdrawn to the bottom of the elliptical flow distributor plate, and the length of travel of the camera was measured. The debris bed depth at these three locations was then derived from the measured length of travel, using the known geometry of the lower head and elliptical flow distributor.

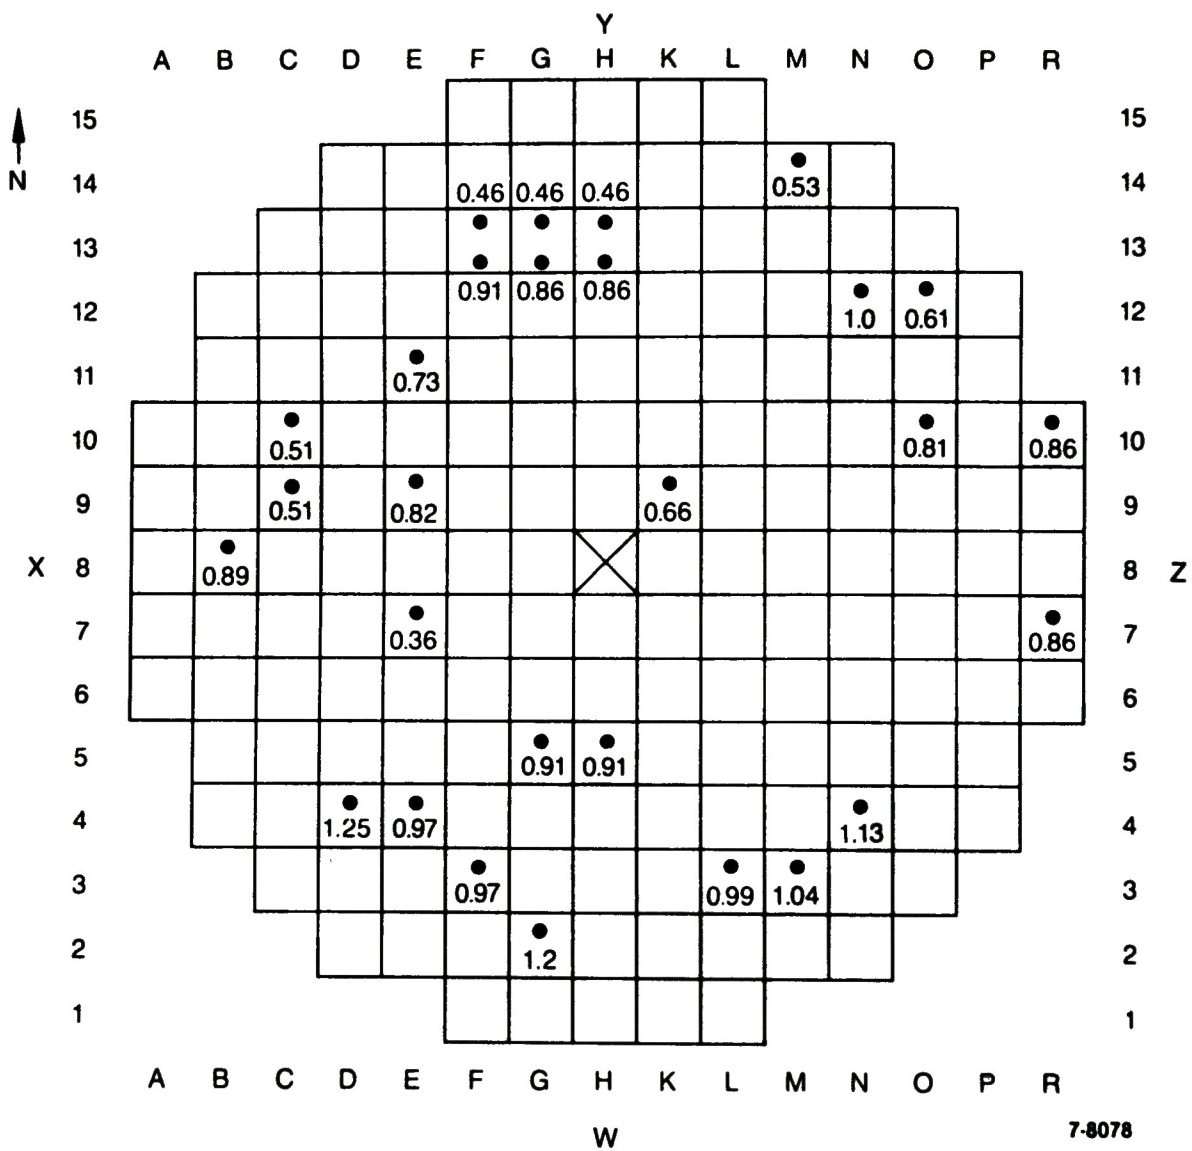
The contour lines for the spherical lower head of the reactor vessel were drawn using the design information for this component. These contours are shown in Figure 4, which is a plane view of the lower head with the core grid superimposed. The depth of the debris bed (at those locations shown in Figure 3) and the contour of the lower head were combined to provide estimates of the debris bed height above an arbitrary reference plane. The reference plane was chosen to intersect with the inside surface of the lower head at the reactor vessel centerline, the 290-ft, 11-in. elevation. These debris bed height estimates are shown in Figure 5.

Figure 5. TMI-2 lower plenum debris bed surface.

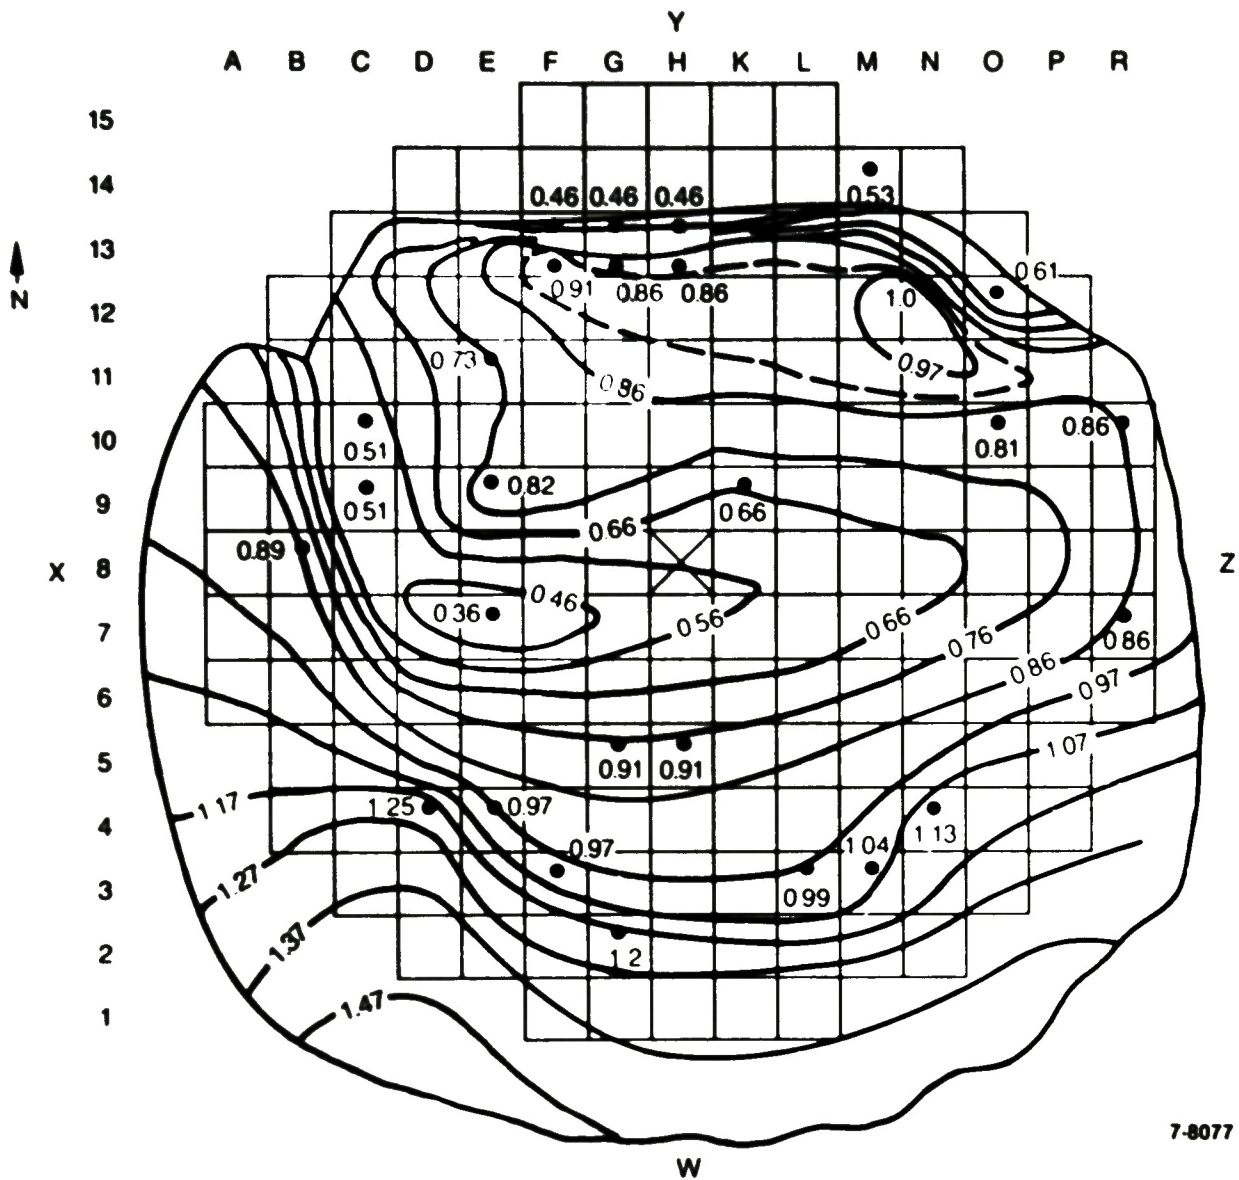
Contour lines were drawn by manually interpolating between the debris bed height data. The manual contouring method is commonly used in geologic and topographic mapping and consists of the following. A contour interval is chosen, based on the range of elevations encompassed by the observation points. In this case, the contour interval was approximately 10 cm (4 in.). Then, contour lines are drawn, using the observation points as controls on the contour line positions and spacing. The resulting continuous surface contour is strictly controlled by the observation points. The contour of the lower plenum debris bed, derived using this method, is shown in Figure 6, which also includes the debris bed height estimates from Figure 5 for comparison.

As shown in Figure 6, the rubble bed extends to near the reactor vessel wall along three axes (W, X, and Z) but only to the last row of instrument guide tubes at the Y axis. This is illustrated by Figures 7 and 8, which are photographs of the lower rubble bed at the W and Y axes, respectively. The abrupt "wall" of debris at the Y axis is evident from Figure 8, while the rubble continues to the downcomer wall at the W axis shown in Figure 7. The top surface of the bed slopes from south to north, with a rounded depression extending from west to east in the central zone.

Figure 6. TMI-2 lower plenum debris bed contour map.
